# Dunyvaig Castle / Conservation Assessment Islay / July 2022

Dunyvaig Castle  
1755A  
Islay  
Scotland

**Islay Heritage**  
Client

28 July 2022

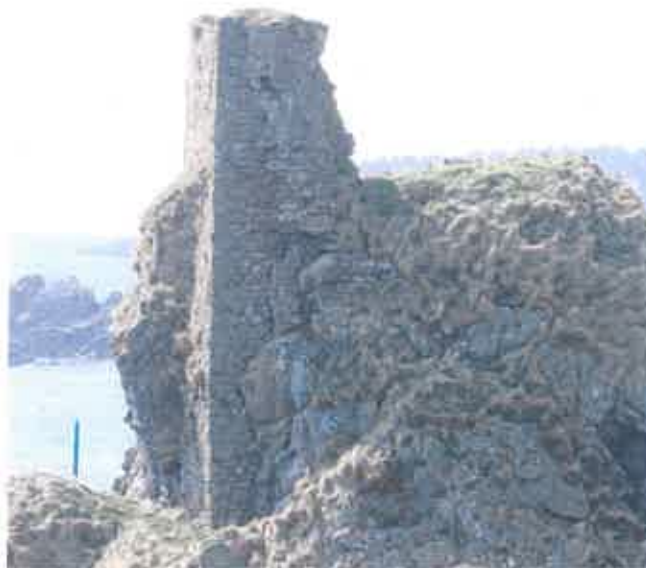
Fig. 11 General view of previously-repaired (1998 emergency works) exterior of the Tower wall on the Summit as viewed from the North East (April 2019)

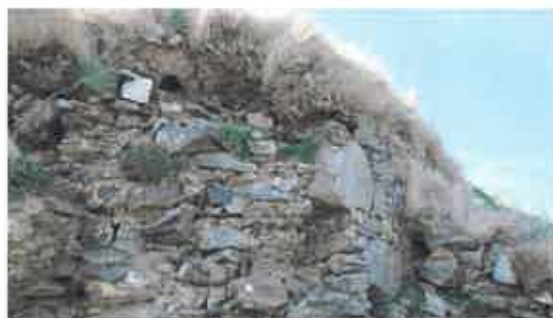
Fig.13 Typical view of undercut wallheads with rabbit burrows that are undermining masonry and footpaths - visible under turf at top and to right. (April 2019)

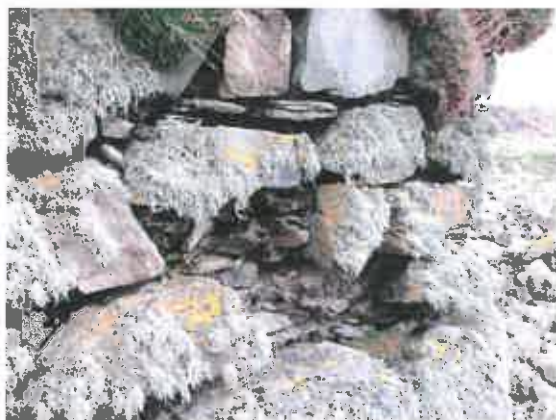
Fig.14 Typical view of lichens on facing stones and small plants growing in crevices (April 2019)

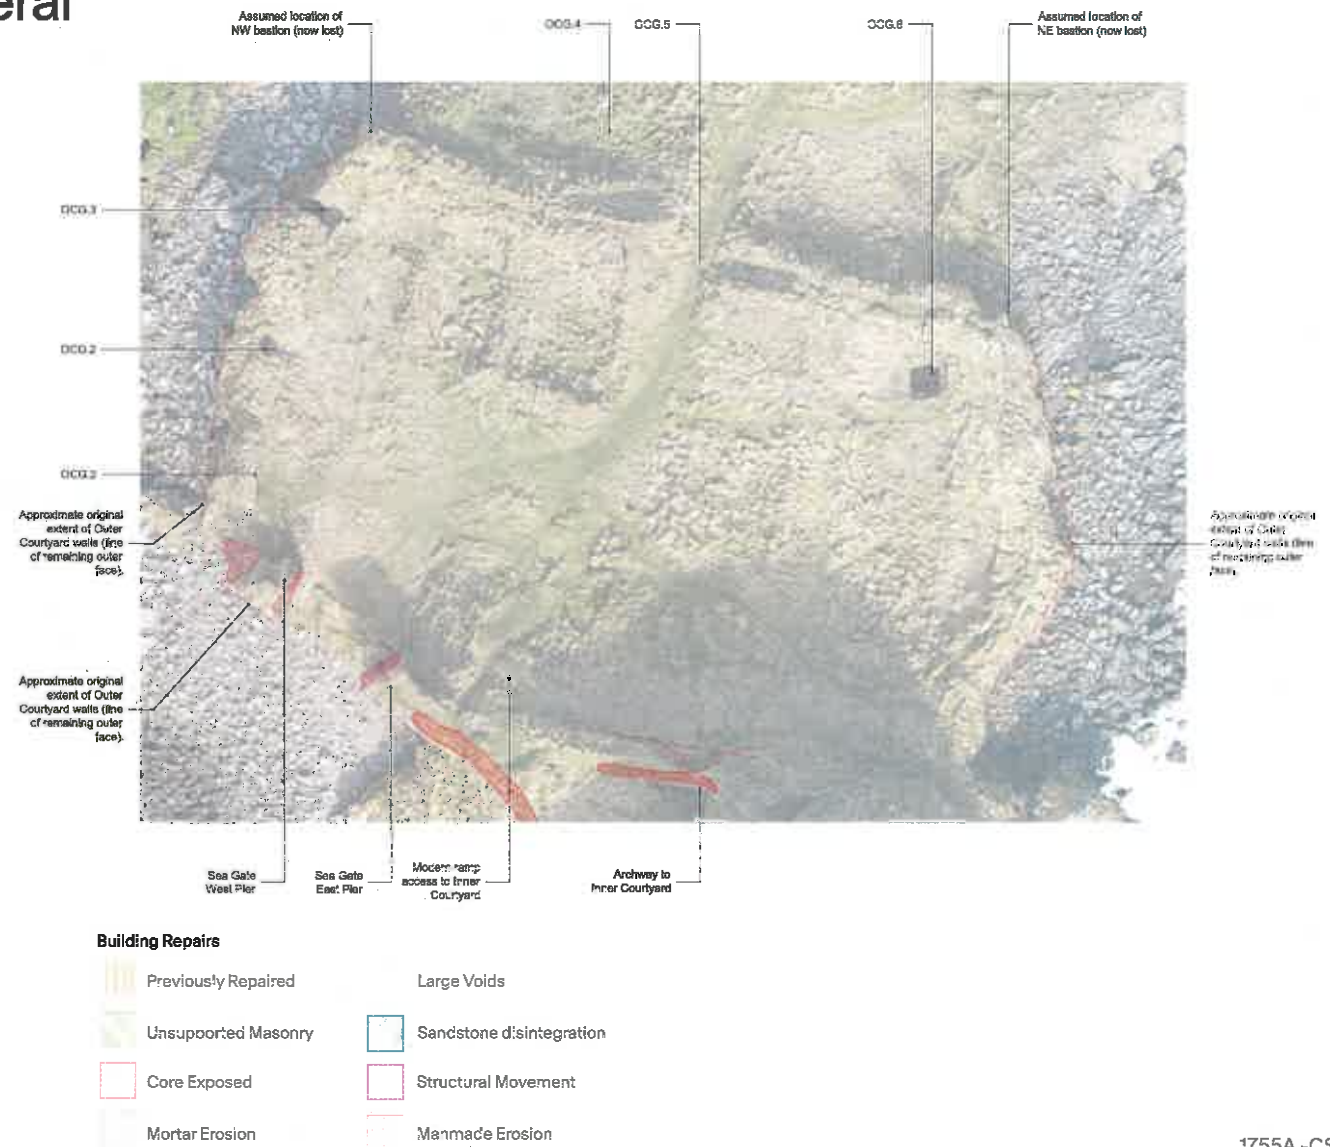
OCG		Outer Courtyard - General		
Item	Description	Photo	Priority	Proposed Repair
OCG.1	Fragment of West wall internal face - Small but relatively intact section of walling with facings in a heavily trafficked area. Short turf capping that suggests it is being eroded by visitors climbing. Stones piled on top by visitors.

Underbuilding is proposed to support the outer wall of the oven. The well should be investigated and may require pinning and packing to prevent collapse. It would be advisable to infill both features with sand and a turf capping to reduce the risk of further deterioration and accident. It would also be advisable to prevent burrowing as this is undermining walls, creating trip hazards and disturbing buried archaeology.

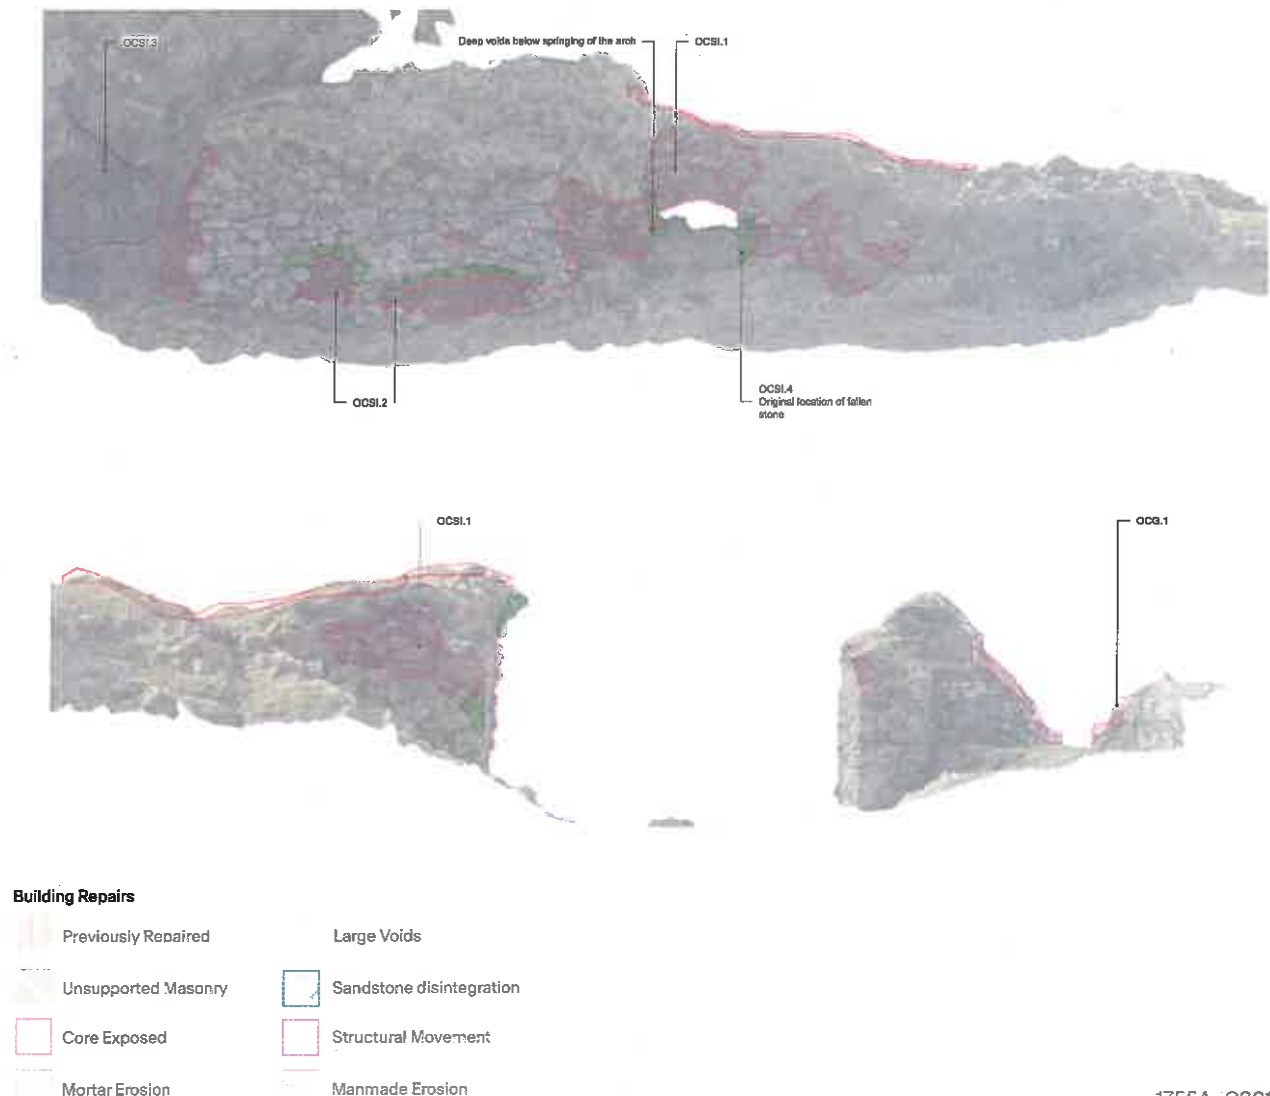
OCSI	Outer Courtyard - South Internal Elevation			
Item	Description	Photo	Priority	Proposed Repair
OCSI.1	General loss of facing stonework and core material - Some of which is leading to poorly supported masonry, especially at the East end and around the archway. A larger area of repairwork has been identified since the survey of 2019. Caused by general mortar weathering. Significant risk of injury as the area is trafficked by visitors.

A mixture of underbuilding and rough racking is proposed to support the remaining facing and arch. The arch itself is to be picked and packed to stabilise the voussoirs. Two non-ferrous bars are also proposed to support the pockets of missing facings.

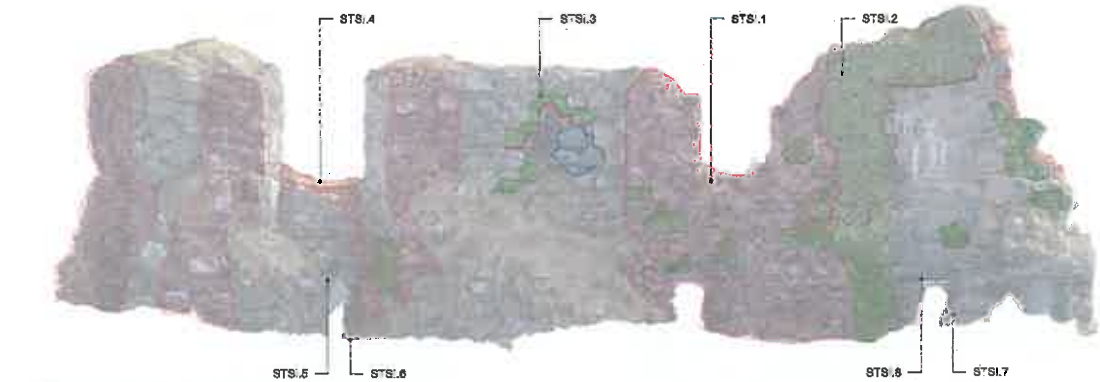
**1.1 Elevation MM**  
Summit - Tower - South Internal Elevation

LV - Large Void	Unfilled/undetected outer layers of masonry with voids behind.	Following more detailed inspection, repair may include grouting and/or braced rebuilding to match existing.
	SD - Sandstone Disintegration	Erosion of the surface of isolated sandstone units, possibly granular disintegration.	Following more detailed inspection, replace sandstone units or braced stone in situ at structurally important locations.
	SM - Structural Movement	Areas of potential structural movement or concern which require investigation and/or remediation, including detached masonry.	Areas to be inspected and GE input required, including pinning of loose masonry and rock.
	ME - Moss/algae erosion	Erosion of protective turf supplies, mainly and most at roadside where walked over by visitors.	Consider installing signage or restricting access, particularly where there is a high risk of injury, and monitor for further deterioration.

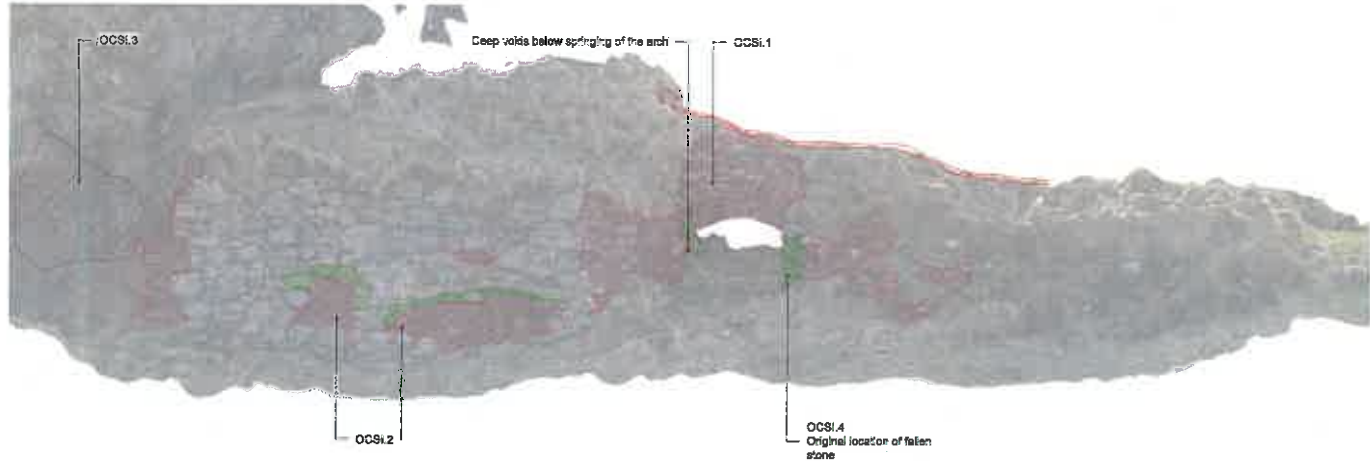
**3.5 Elevation II**  
Outer Courtyard - South Internal Elevation

LV - Large Voids	Unfilled/abandoned outer layers of masonry with voids behind.	Following more detailed inspection, repairs may include grouting and/or limited rebuilding to match existing.
	SD - Sandstone Disintegration	Erosion of the surface of isolated sandstone units, possibly granular disintegration.	Following more detailed inspection, repairs may include grouting and/or limited rebuilding to match existing.
	SM - Structural Movement	Areas of potential structural movement or concern which require investigation and/or remediation, including detached masonry.	Areas to be inspected and BS input required, including pinning of loose masonry and out.
	ME - Mortar Erosion	Erosion of protective leaf courses, masonry and mortar at wall-head where washed over by shingles.	Consider installing signage or netting access, particularly where there is a high risk of injury, and monitor for further deterioration.
