DUNYVAIG CASTLE

Results of the electrical resistance and the terrestrial 3D laser scan surveys

August 2017

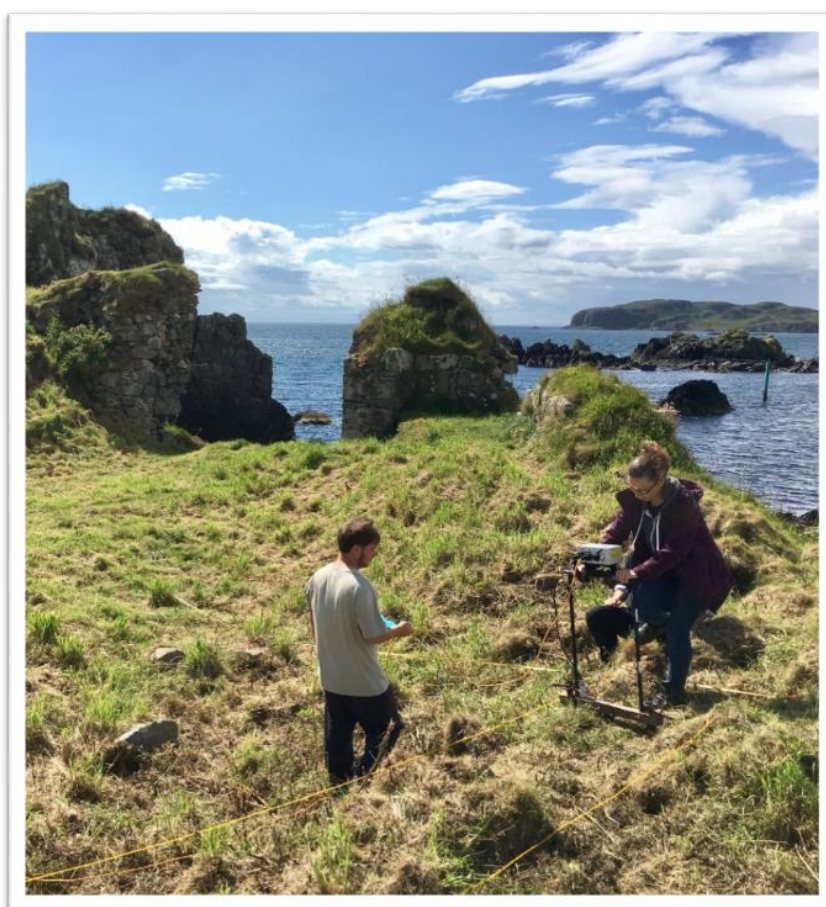
Electrical resistance survey was carried out by a team from the University of Reading led by Dr Robert Fry. The survey was carried out using RM-15 electrical resistance meter with twin probe configuration, 0.5m probe spacing, 0.5m traverse spacing and 0.5m interval spacing. In other words, the resolution of the data collected is 0.5m in any direction. The survey is conducted in 20m grid squares, one at a time, which are then 'stitched up' during the computer processing of the results, thus giving us a continuous plot of the survey area (Figure 2). The extent of this initial survey, which will be extended in 2018, can be seen in Figure 1. It shows the aerial view of the promontory with the plan of the castle on the left and the geophysical results on the right. The hall building or the tower, as it is sometimes also known as, was inaccessible to this type of survey and, in fact, there would be a very little point to it considering it is situated on the rock stack and covered in rubble. Thus the survey focused on the courtyard area and the ground beyond the castle walls, which is probably the most interesting, as its archaeological potential is largely unknown. The results are presented as greyscale images in which dark areas are the areas of high resistance and the light areas the areas of low resistance.

Figure 2 Electrical resistance survey at Dunyvaig castle. The surveyor holds the frame with the resistance meter mounted on the top and the electrodes making contact with the ground below.

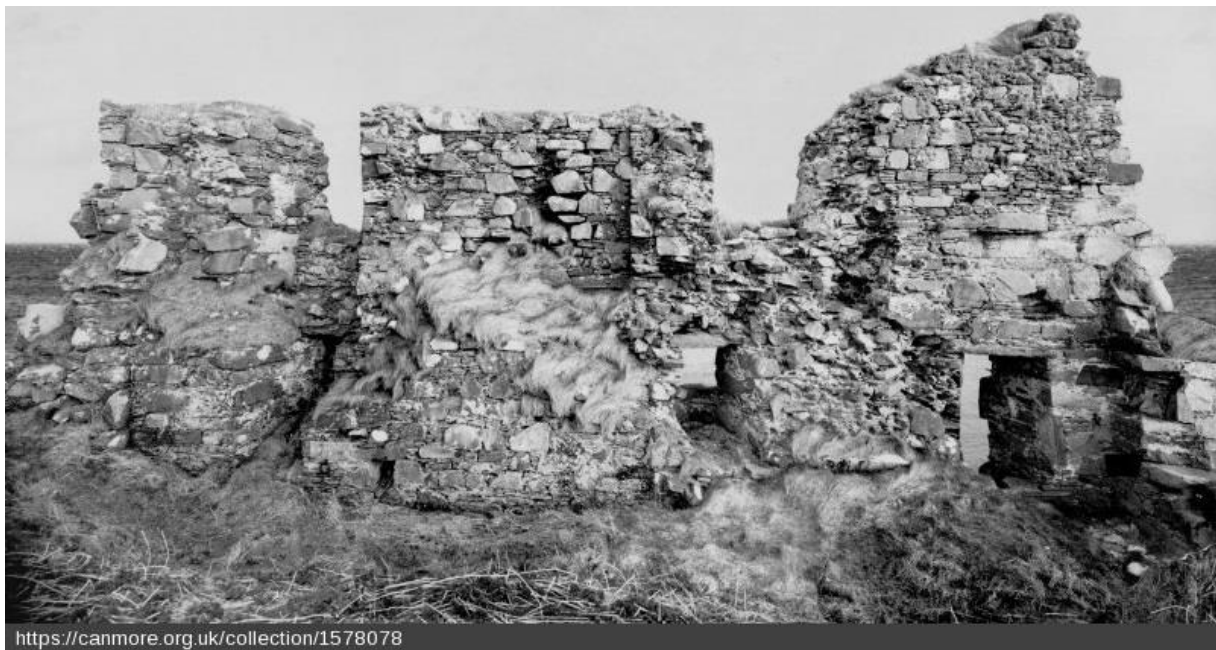
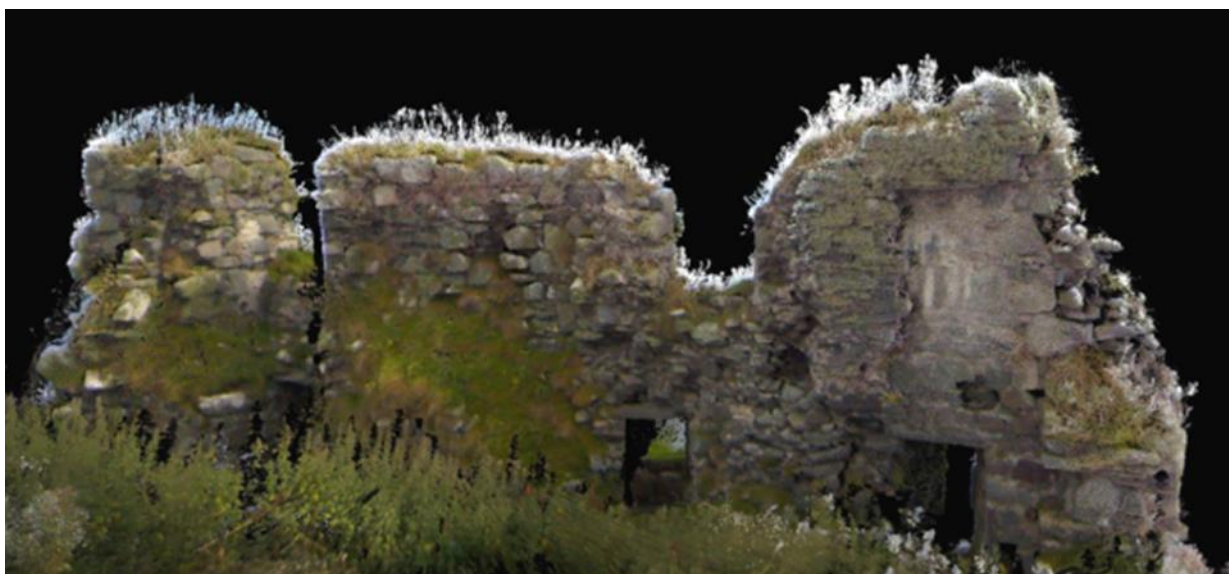
Figure 7 View of the inner face of the southern wall of the hall building in 1983 (top) and a still image from the 3d laser scan survey in 2017 (bottom).

The passage of time can also be seen in the preservation of the upstanding walls, which have deteriorated in the last 20 years or so (Figure 7). Comparison between the photographs held by the Historic Environment Scotland and the 2017 survey shows that certain parts of the wall face have crumbled away and the walls are more affected by the vegetation and the roots which crumble away the mortar and loosed the stones.

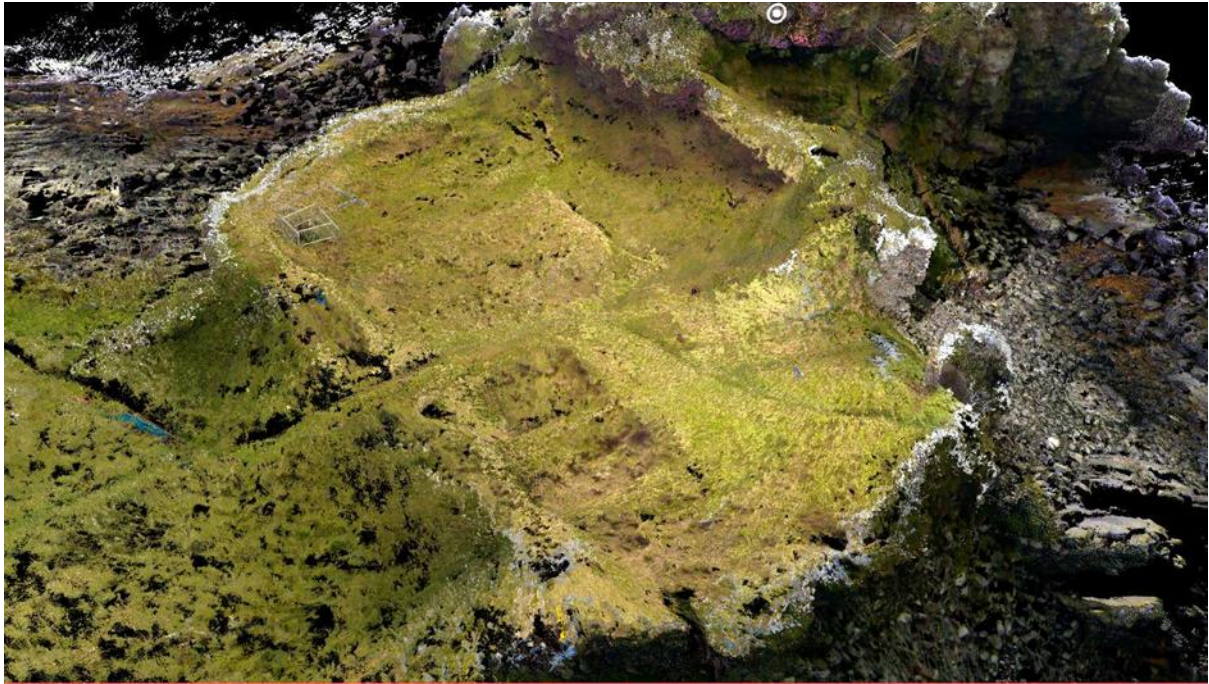
Figure 8 Laser scan survey model of the courtyard with photographic cover as seen from the northwest
