MEDIEVAL AND LATER SETTLEMENT ON THE ISLAND OF ISLAY

ARCHAEOLOGICAL SURVEY AND EXCAVATION AT THE
TOWNSHIP OF OLISTADH

BY ELAINE JAMIESON, TREVOR PEARSON AND AMANDA CLARKE

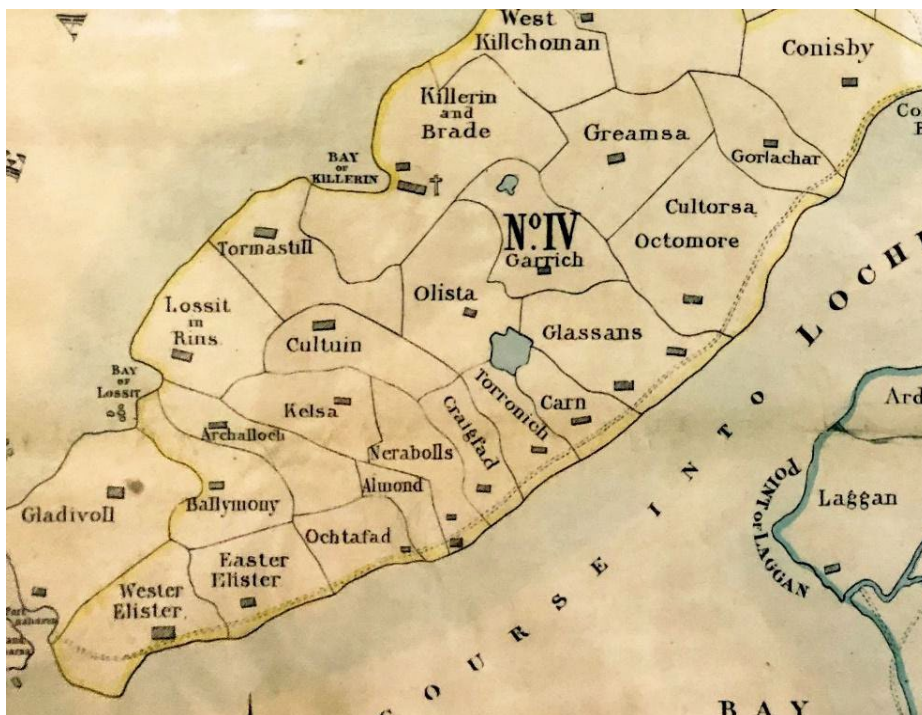
Figure 2. Detail from Stephen MacDougall's map of the Island of Islay showing the farming district of Olistadh. (Photograph: Elaine Jamieson)

The township of Olistadh is depicted on Stephen MacDougall's map of the Island of Islay (1749-51), the earliest to show the relative location and boundaries of its farm districts (Figure 2). Olistadh is also shown on George Langlands map of Argyllshire printed in 1801, although the scale of the map doesn't allow for the depiction of individual buildings. Four structures and an enclosure were mapped at Olistadh by the Ordnance Survey in c. 1867-1875 for their One-Inch map (*Bowmore*, Sheet 19 1885), with the buildings depicted as unroofed and the township abandoned. By 1878 cartographic evidence indicates a sheepfold and shepherds' cottage had been constructed at the site and marks the holding's conversion to sheep-farming, a common aspect of agricultural Improvement on the hill country of Islay from the mid-19th century (*Argyllshire, Sheet CCXVIII 1882*; Caldwell 2011, 86).

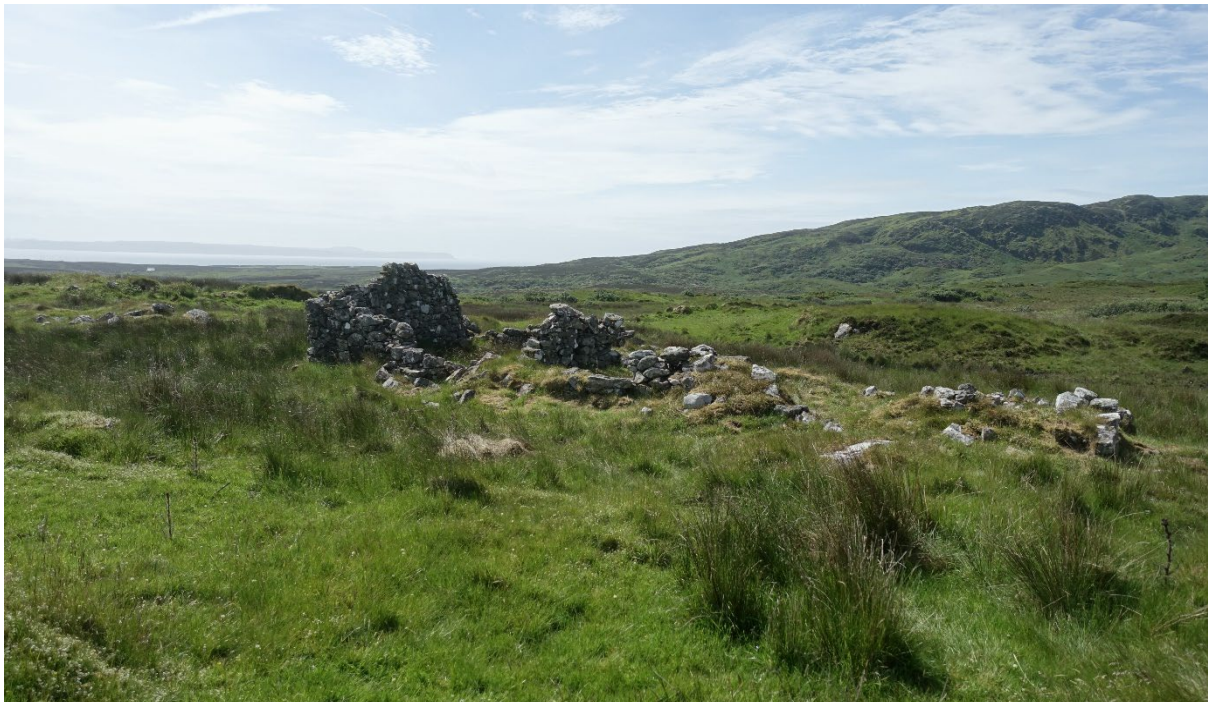
*Figure 5: Looking south over Building 1 with Beinn Tart à Mhill and Loch Indaal in the background.
(Photograph: Trevor Pearson)*

What is clear from the survey is that all the buildings exhibit much evidence for rebuilding and re-use. Building 4 likely started life as a two-room dwelling, with one of the rooms later abandoned and the remainder rebuilt as a barn or byre measuring 9.5m by 5.3m. The opposing entrances of the barn were later crudely blocked with rubble and the structure possibly repurposed as an animal shelter (Figure 6). The slight earthwork remains of a small building (a), measuring 4.8m by 5.9m, were also identified on the north side of Building 4, the structure clearly pre-dating the bank of an adjoining enclosure and possibly representing a small outbuilding from an earlier phase of occupation. Building 1 was rebuilt at its western end, the refashioned structure constructed on a slightly different alignment and rather clumsily joined to the earlier house by a curving stone wall (Figure 5).

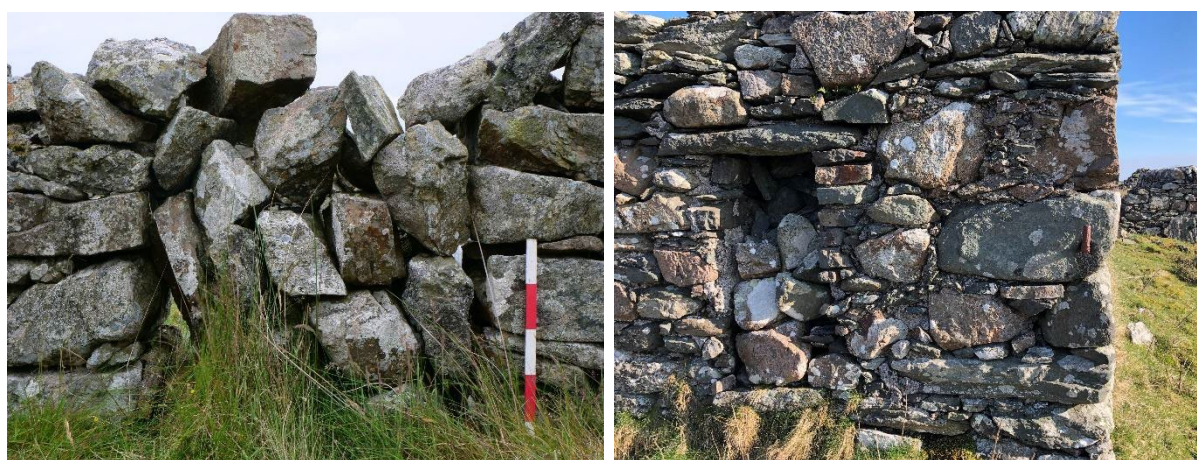
Figure 6: One of the crudely block entrances to Building 4 (left); Mortared joints and roughly dressed quoins of Building 5 (right). (Photographs: Trevor Pearson & Elaine Jamieson)

The move to a livestock-based economy was complete by the end of the century when a sheepfold was constructed at Olistadh. The principal component of the complex was Building 5, a single-storey structure which measures 18.6m by 6.7m over walls up to 1m thick and is interpreted here as a shepherds' cottage. In contrast to the other structures on the site, the coursed-rubble walls of Building 5 display clear evidence for mortared joints with roughly dressed quoins to their corners (Figure 6). It is also the only building with a fireplace, and has a flue built against its internal cross-wall and possibly also in its northern gable (although the latter was obscured by dense vegetation at the time of the survey). This could suggest the main room was divided internally, perhaps by a timber partition or box beds. An enclosed and gated yard and drystone pens for protecting ewes and lambs at lambing time were built adjoining the eastern side of the dwelling-house. Further yards were later added to the north and south, with much of the stonework for the walls robbed from the abandoned structures of the earlier township.

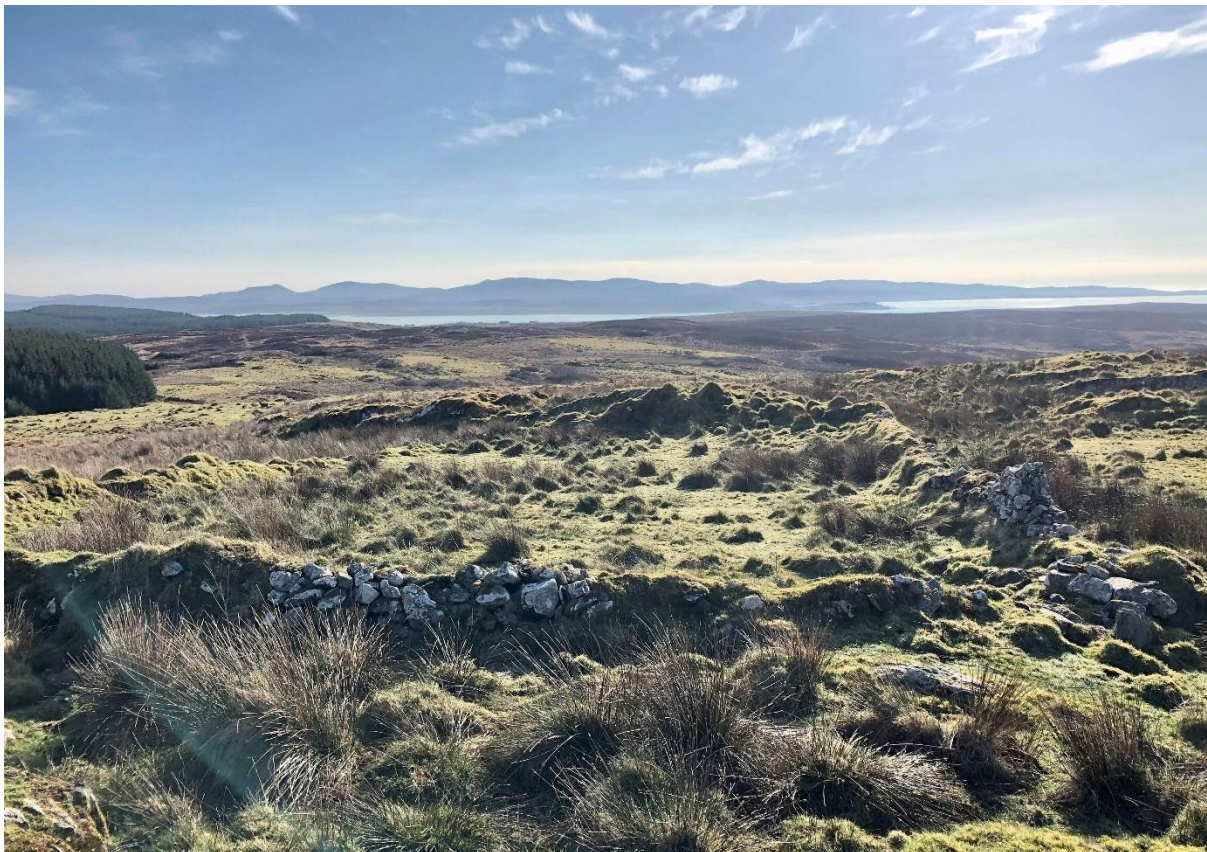
Figure 7: Looking east over enclosure (d) and the main east to west trackway through the township (on the right), with Loch Indaal in the distance. (Photograph: Elaine Jamieson)

The lower iteration of the head-dyke to the northeast is partly overlain by a large, sub-rectangular enclosure (d) which is set into the head of a broad natural gully (Figure 7). The enclosure extends to over 551 square metres in area and is formed by stone-and-turf walls with rounded corners, the boundary also incorporating a natural rock outcrop in its eastern side. The enclosure's southern boundary follows and partly overlies the east to west route through the township, suggesting both the route and the earlier phase of head-dyke pre-date the construction of the enclosure. Built into the enclosure's south wall are the remains of a small gable-ended structure, possibly an animal pen or shelter. The enclosure may have been constructed as a stackyard, although narrow spade-dug rig no more than 14m long and 2.6m wide can be seen in the interior and indicate an episode of small-scale cultivation.

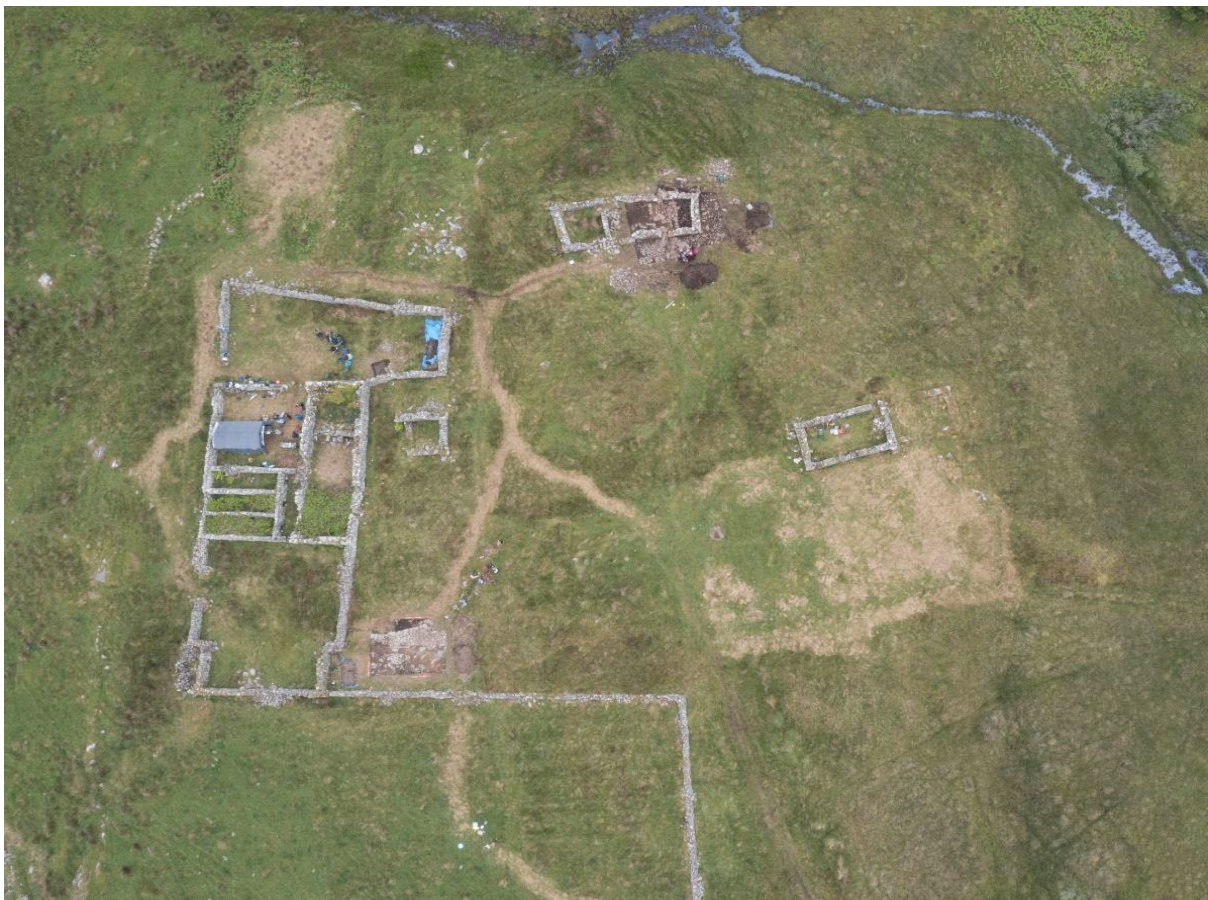
Figure 8: Aerial image showing the remains of Olistadh township, the sheepfold and the location of the 2022 trenches: Trench One (top centre) and Trench Two (bottom left). (Photograph: Sarah Lambert-Gates).

Two areas were selected for excavation during the University of Reading field school in 2022, the excavations directed by the third named author. Trench One was positioned over the western end of Building 1 to establish the character of the archaeological remains and to explore the structure's internal layout. Trench Two was located at the north-western end of Building 2 to investigate the curving grass-covered bank noted in the earthwork survey. Four slots were also dug across features in both trenches to test their construction and preservation. Neither trench was fully excavated, and both will be revisited during the 2023 excavation season; what follows represents an interim statement only.

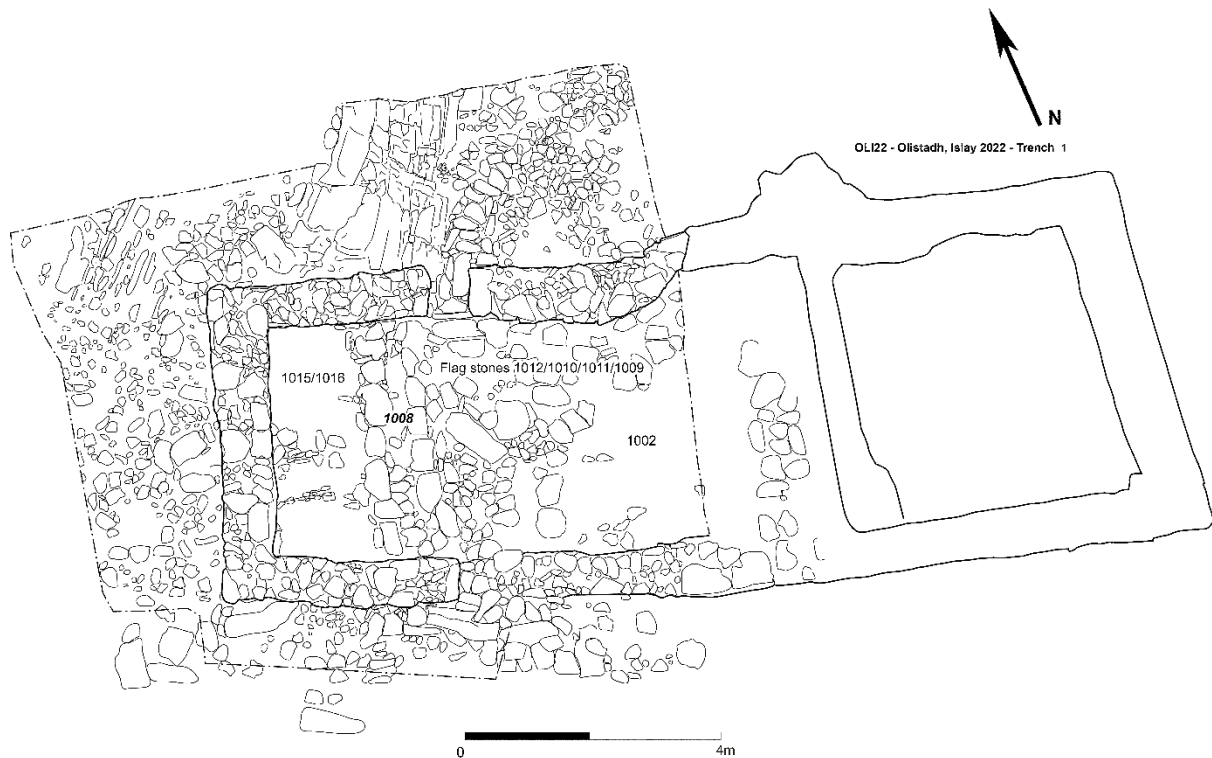
Figure 9: Plan of Trench One. (Illustration: University of Reading)

Trench One, measuring approximately 10 x 10m, was located at the western end of Building 1, a well-preserved structure with little in the way of collapsed building rubble and therefore offering a substantial internal area suitable for detailed excavation (Figure 9). The building is set into the natural slope of the hillside above the western watercourse and is clearly adapted to utilise the naturally outcropping bedrock, a practice noted from elsewhere on the site. The structure is raised out of the boggy ground to the south by means of a stone platform set against the southern side of the building, with extra stone support and reinforcement also present at its south-western corner. Removal of the topsoil and rubble outside the footprint of the structure on its northern side revealed a cobbled surface and laid flagged pathway leading up to the stone threshold of the north entrance.

Inside the building, the rubble was removed by hand and the vegetation and compacted topsoil was excavated down onto two distinct surfaces which were separated by a substantial stone-lined and capped drain [1008]. Situated to the west of the building's opposing entranceways, the drain utilised the underlying bedrock and ran through the building following the natural slope and out via an outlet in its southern wall. The area to the west of the stone-lined drain was a maximum of 1.8m in width and comprised an interleaving deposit of compacted peat overlying a rough mixed earth, clay and stone surface [1015/1016]. This surface was divided into narrow 'compartments' by edgings of small stones and runnels or grooves for drainage, the smallest 'compartment' no more than 0.7m wide. The area to the east of the drain included a surface of flagged paving and clay flooring [1012/1010/1011/1009] incorporating a substantial burnt deposit located roughly centrally within the space [1002].

The excavation would appear to confirm that the western end of Building 1 was rebuilt as a byre-dwelling with opposing doors, the new structure on a slightly different alignment and marginally narrower than the earlier building it adjoins. The pottery, glass, and a variety of iron implements recovered from within the building suggest a date of the early to mid-1850s, indicating the house was possibly abandoned around the same time the township was cleared.
