# Dunyvaig Castle / Conservation Assessment Islay / July 2022

Dunyvaig Castle  
1755A  
Islay  
Scotland

**Islay Heritage**  
Client

28 July 2022

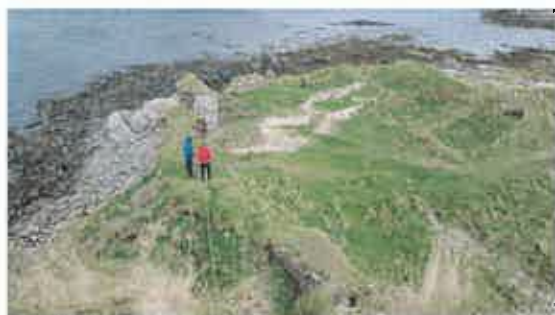
Fig. 7 General view of Outer Courtyard as viewed from the Summit (April 2019)

the outer courtyard that is not currently affecting the standing structures. Turf cappings/upper walls appear to be providing protection to the masonry below, absorbing moisture that would otherwise wash out more of the mortar. Sea thrift and other small plants have colonised crevices, and lichen has grown on the original facing stones, but these do not seem to be adversely affecting the structure of the walls.

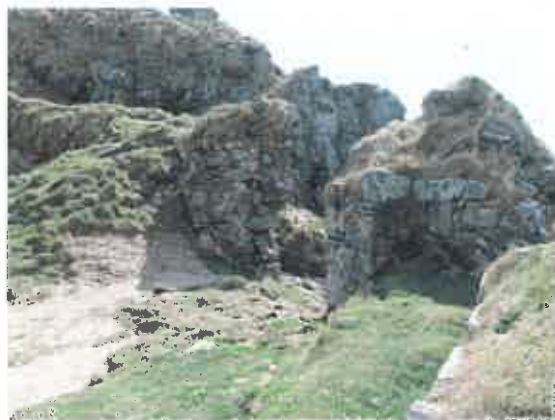
Fig. 8 General view of the seagate from the Outer Courtyard, with the footpath to the Inner Courtyard to the left (April 2019)

Both sections of wall on either side of the south wall seagate have also lost pockets of facing stones, particularly at the exposed corners. The interior of the south wall, facing into the outer courtyard, has a mixture of problems: fissures in the face of the adjacent high level bedrock, and missing facing stones and deep voids formed under the arched opening that require Immediate repair (although some of these may have been pockets for supporting timberwork that has since rotted away or a drawbolt).

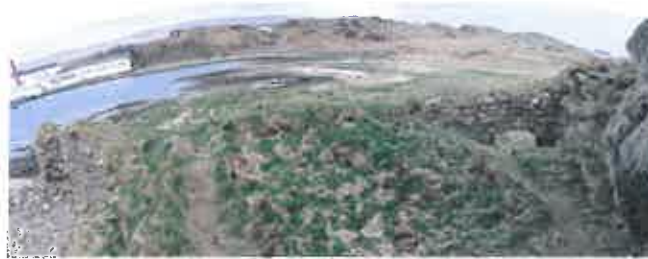
The condition of the arched opening is the same as described above. As the opening is now too low to be accessible except on hands and knees, an informal pathway has developed through the inner courtyard from the outer courtyard to the summit. This path runs along a mound of grassed rubble and turfed wallheads, with a steep drop of several metres on one side, and is eroding to expose earth.

Fig. 9 General view of Inner Courtyard looking North to the arched opening from the Lower Courtyard to right, and current footpath over fallen rubble to the left (April 2019)

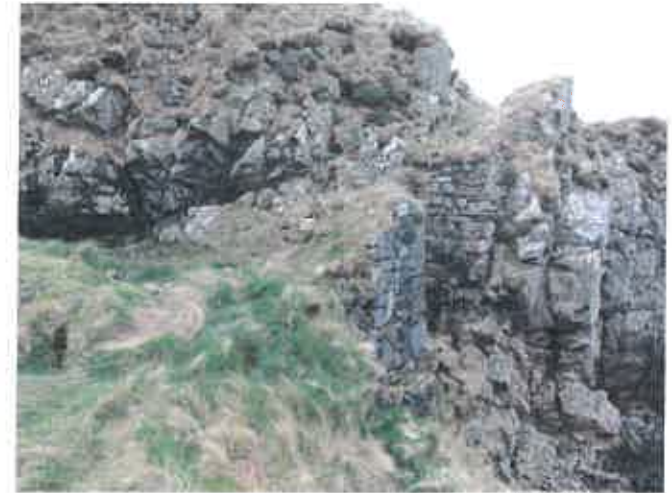
Since 2019, a stone has fallen out of the walls leading to the drawbridge, and larger areas are now identified as requiring underbuilding or rough racking. Limited areas require Urgent repair.

Fig. 10 General view of Inner Courtyard looking East to the drawbridge leading up to the Summit (April 2019)

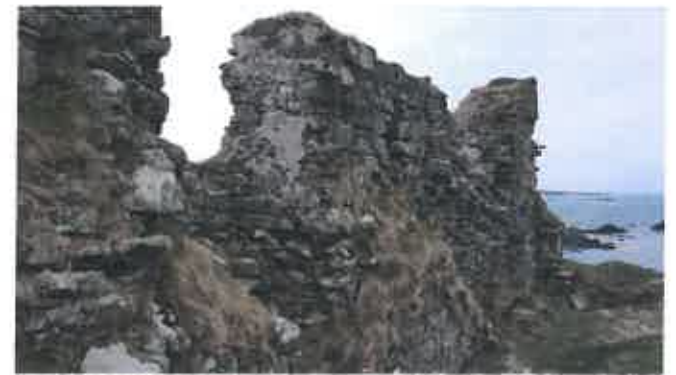
Fig. 12 General view of interior of the tower wall on the Summit (April 2019)

Since 2019, a stone has fallen out of the tower walls, and larger areas are now identified as requiring underbuilding, rough racking and further inspection. Limited areas require Urgent repair.

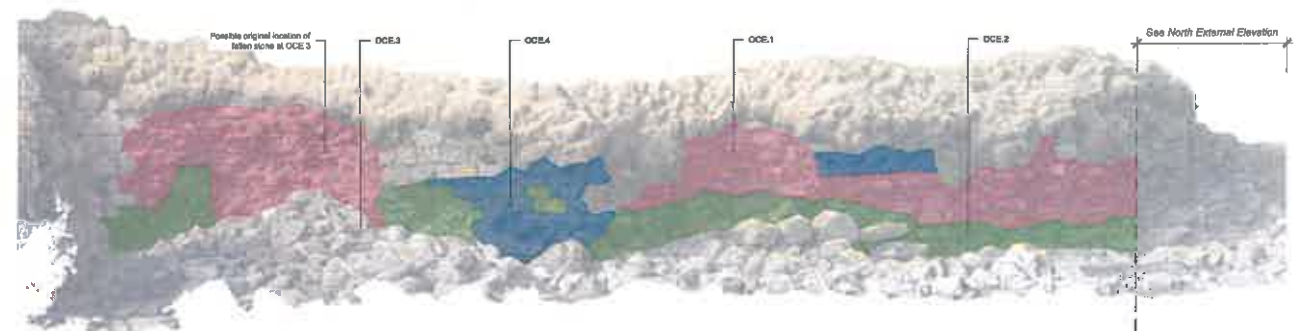
This area is in poor condition and many works to this area are Urgent. In addition to the bastion to the NE, large areas of facing stones have been lost up to a depth of 1.2m, exposing the wall core. The remaining facing and turf above have little support in some areas. Three stones from the face appear to have fallen out onto the shore since 2019.

A mixture of underbuilding and rough racking is proposed to support the remaining facing. Gabions or other sea defences on the shore should be considered.

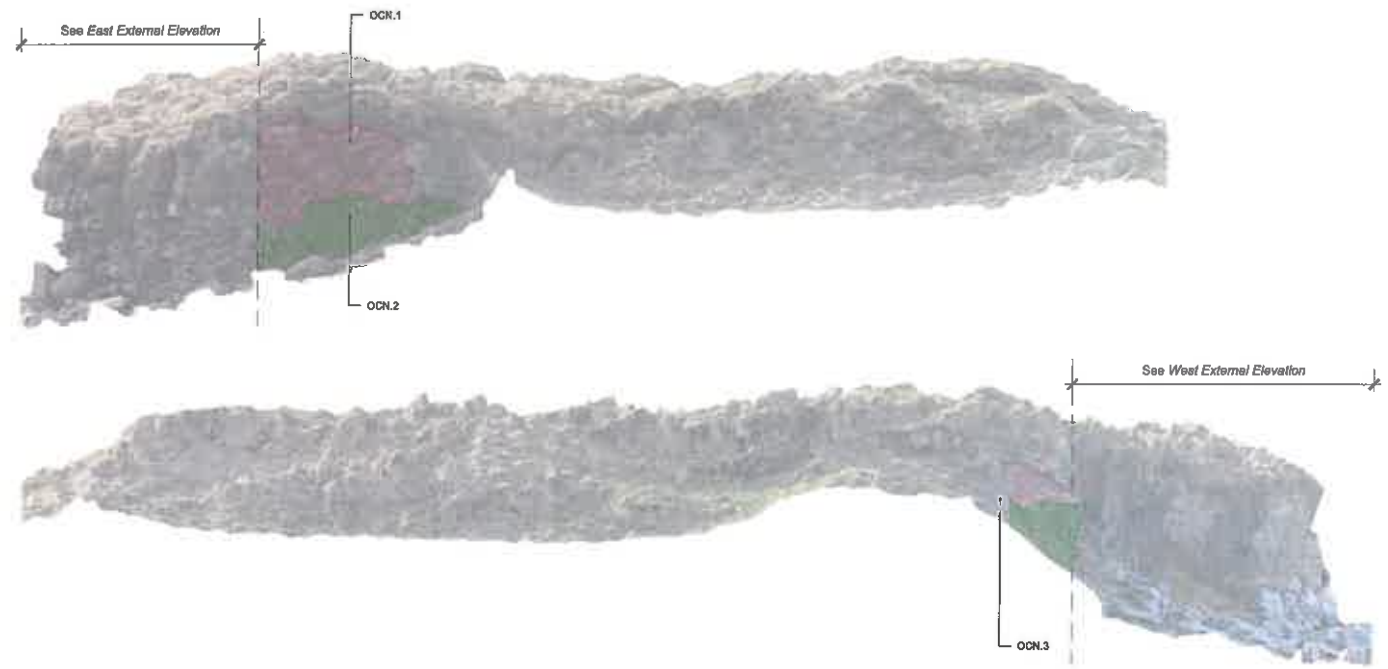
Little masonry is visible on this elevation and the area is generally in good condition, except poor condition areas where the bastions have been lost, exposing the wall core and with masonry loss visible since 2019. These works are Urgent.

A mixture of underbuilding and rough racking is proposed to stabilise the exposed masonry.

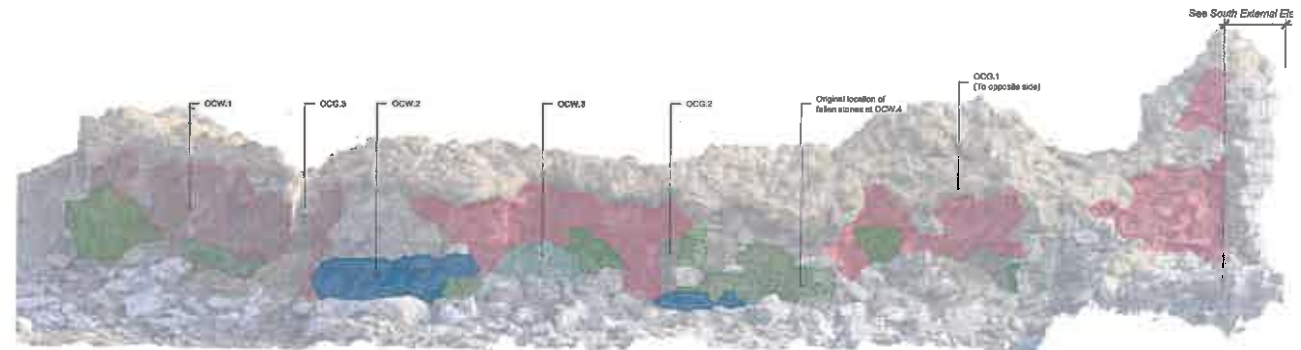
This area is in poor condition and many works to this area are classed as Immediate or Urgent. In addition to the bastion to the NW, large areas of facing stones have been lost, exposing the wall core. The remaining facing and turf above have little support in some areas. Lintels only remain over one embrasure - see General for details. There has been deterioration since 2019; a central area has slumped forward revealing a deep void behind, and a nearby area of facing has fallen onto the shore.

OCW		Outer Courtyard - West External Elevation		
Item	Description	Photo	Priority	Proposed Repair
OCW.1	General loss of facing stonework and core material - Very deep in places, some of which is leading to poorly supported masonry and turf cappings, especially around embrasures. A larger area of repairwork has been identified since the survey of 2019. Caused by general mortar weathering and physical wave action. Significant risk of injury through falls as wallheads are a heavily trafficked area.

OCW.3	Collapsed area to base at North end - A deep void has been revealed at the base of the wall since 2019, with outer masonry appearing to have slumped outwards. Cause as OCW.2.

A mixture of underbuilding and rough racking is proposed to support the remaining facing. Gabions or other sea defences on the shore should be considered.

Urgent / Desirable	Rough rack or underbuild only as necessary to stabilise walling. Any repairs should leave the various walls and blocked openings legible in the area of the lost bastion and lost SW corner embrasure.  Consider general packing, pinning and repointing of eroded mortar joints to remaining facings generally to slow general deterioration.
OCW.2	General damage to wall base - Walling is generally in a poorer condition at the base. A larger area of repairwork has been identified since the survey of 2019. Caused by natural erosion of the shattered stone and physical wave action, although more sheltered than the similar East Elevation. This may be exacerbated in future by forecast sea level rises.

Urgent / Desirable	Ensure any rough racking or underbuilding is commenced from sound bedrock, reusing any loose masonry in the repairs as necessary.  Consider installation of protective gabions or other sea defences to slow the impact of wave action and deterioration generally, and general packing, pinning and repointing of eroded mortar joints.

Immediate	Following more detailed inspection, repairs may include grouting to stabilise the void followed by limited rebuilding reusing existing masonry to match existing.
OCW.4	Stonework fallen onto shore at centre - 2-3 large grouped stones have fallen from mid-level onto the shoreline since 2019. Case as OCW.1.

Desirable	Reinstate lost stone in its original position only if this can be determined accurately. If not, leave in situ. Repairs around as OCW.1.

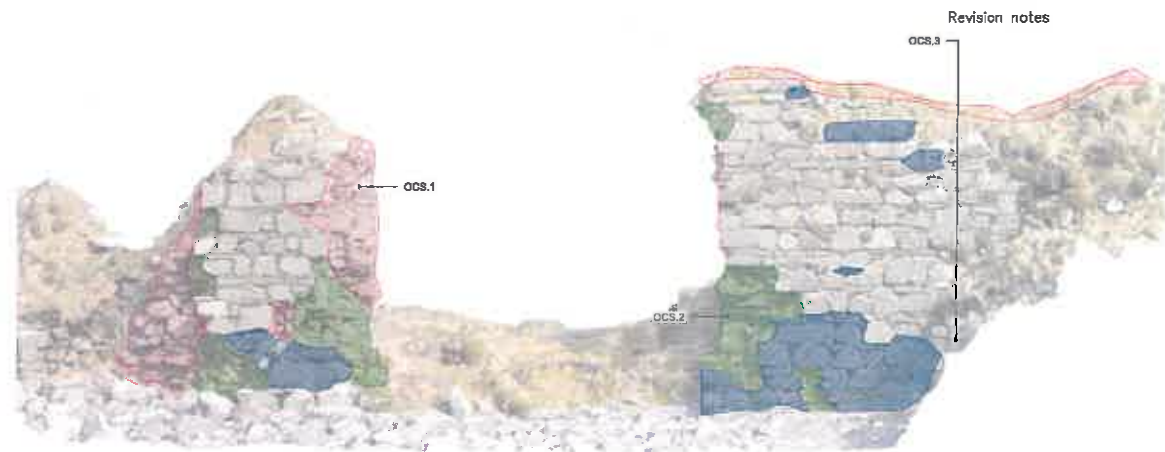
This area is generally in poor condition and many works to this area are Urgent. The SW corner and some areas of facing stones have been lost, on the corners of the jambs in particular. The remaining facing and turf above have little support in some areas. There is a risband joint between the main walling and a poorly-built later wall to the right and this area is in very poor condition. There has been no obvious loss of masonry since 2019.

OCS		Outer Courtyard - South External Elevation		
Item	Description	Photo	Priority	Proposed Repair
OCS.1	General loss of facing stonework and core material - Very deep in places, some of which is leading to poorly supported masonry and turf cappings. A larger area of repairwork has been identified since the survey of 2019. Caused by general mortar weathering and physical wave action. Significant risk of Injury through falls as East Seagate wallhead is trafficked by visitors.

OCS.3	Detached later walling - A low section of walling by the East Seagate is not tied into the earlier walling and is now unstable as it has deeply eroded mortar joints, a missing stone at the base and large voids behind. The turf capping to this area has visible eroded since photographs from 1962.

A mixture of underbuilding and rough racking is proposed to support the remaining facing. Gabions or other sea defences on the shore should be considered.

Urgent	Rough rack or underbuild only as necessary to stabilise walling.  Consider general packing, pinning and repointing of eroded mortar joints to remaining facings generally to slow general deterioration.
OCS.2	General damage to wall base - Walling is generally in a poorer condition at the base. A larger area of repairwork has been identified since the survey of 2019. Caused by natural erosion of the shattered stone and physical wave action, although more sheltered than the similar East Elevation. This may be exacerbated in future by forecast sea level rises.

Urgent	Ensure any rough racking or underbuilding is commenced from sound bedrock, reusing any loose masonry in the repairs as necessary.  Consider installation of protective gablons or other sea defences to slow the impact of wave action and deterioration generally, and general packing, pinning and repointing of eroded mortar joints.

Urgent	Following more detailed inspection, repairs may include grouting to stabilise followed limited rebuilding reusing existing masonry to match existing. Turf capping should be reinstated to protect the wallhead.

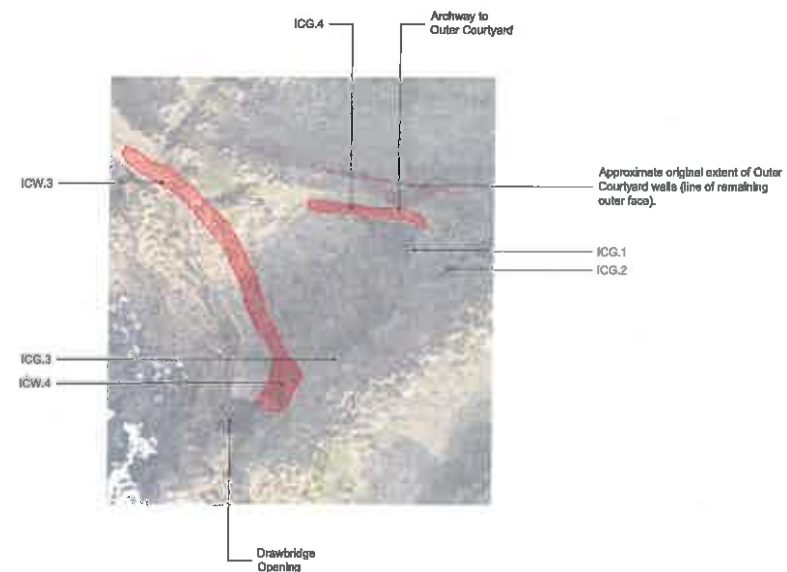
This area is generally in fair condition except for a void in the wall to the East of the archway where facing stones have been lost - this area requires immediate repair. Water seepage through the fractured bedrock below the higher section of masonry should be monitored. There has been no obvious deterioration of masonry since 2019.

Underbuilding is proposed to infill the void by the arch.

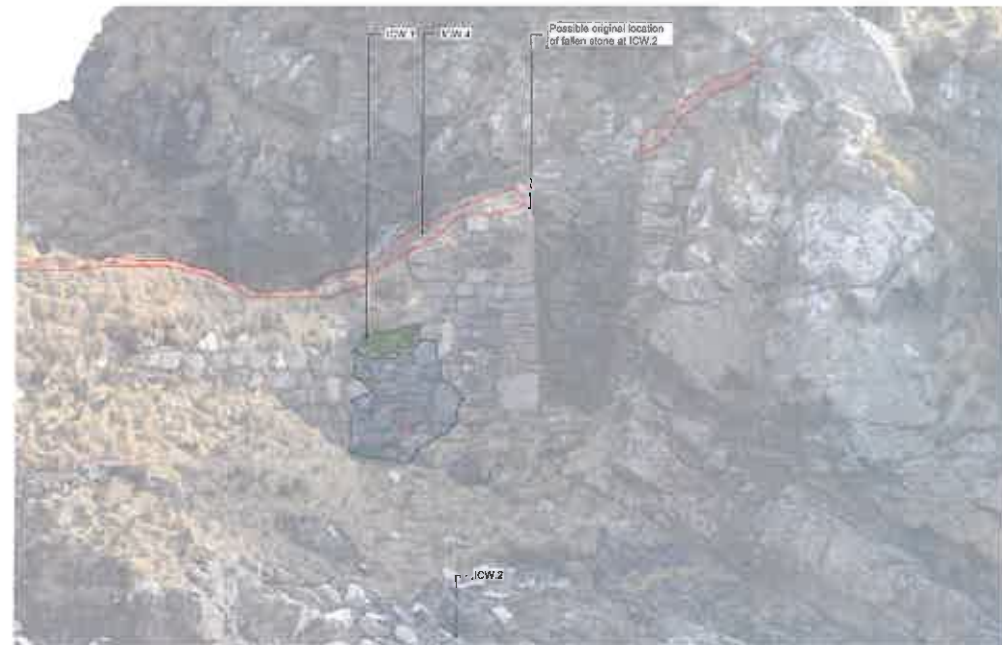
This area is generally in fair condition as there is only one small pocket of missing facing stones and both sides of the drawbridge masonry appear stable. Limited works in this area are Urgent. There is a small amount of erosion to the walltop where it is used as a path, especially at the head of the East seagate and at the drawbridge. Since 2019, a stone appears to have fallen out onto the shore; it is unclear whether it has been dislodged from the the top edge of the drawbridge opening or elsewhere.

ICW		Inner Courtyard - West External Elevation		
Item	Description	Photo	Priority	Proposed Repair
ICW.1	Pocket of missing facing - Loss of facing stonework in a pocket below the informal footpath on top of the wall. Caused by general mortar weathering. Significant risk of injury as the area is trafficked by visitors and there is a 3+m drop to the shoreline below.

ICW.3	Erosion at East seagate - Visitors are observed walking onto the top of the East seagate, where there is poorly supported masonry below. Significant risk of injury as the area is trafficked by visitors and there is a 3+m drop to the shoreline below. See also OCS.1.

Rough racking is proposed to support the remaining facing in the pocket. It may be advisable to consider preventing access to the summit, due to the risk of falling from height, by installation of a barrier before the drawbridge.

Urgent / Desirable	Rough rack or underbuild only as necessary to stabilise the facing above.  Consider general packing, pinning and repointing of eroded mortar joints to remaining facings generally to slow general deterioration.
ICW.2	Fallen stone - A stone has recently fallen onto the shore below the wall, possibly since 2019. It appears that this stone may have been dislodged from the edge of the drawbridge opening as the remainder of the walling appears to be in fair condition with pinning mainly intact.

Desirable	Reinstate lost stone in its original position if this can be accurately determined. Repairs around as ICW.1.  See also ICW.3.

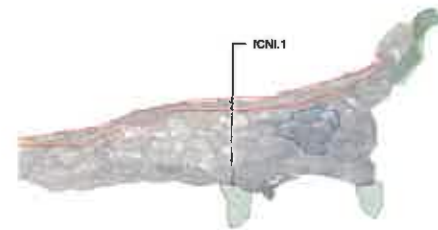
Although the facings around the archway are more intact than the side facing the Outer Courtyard, this elevation is generally in very poor condition, and works in this area are Immediate/Urgent. Refer to Outer Courtyard - South Internal Elevation for details of the archway condition and proposed works. There has been no obvious deterioration of masonry on this side of the walling since 2019.

ICNI				
Inner Courtyard - North Internal Elevation				
Item	Description	Photo	Priority	Proposed Repair
ICNI.1	<p>Loss of pockets of masonry to either side of the arch at springing level, and gaps between small voussoirs. Caused by general mortar weathering. No visible deterioration since 2019. Significant risk of injury if the arch should fail as the area is trafficked by visitors.</p> <p>See also Outer Courtyard - South Internal Elevation</p>

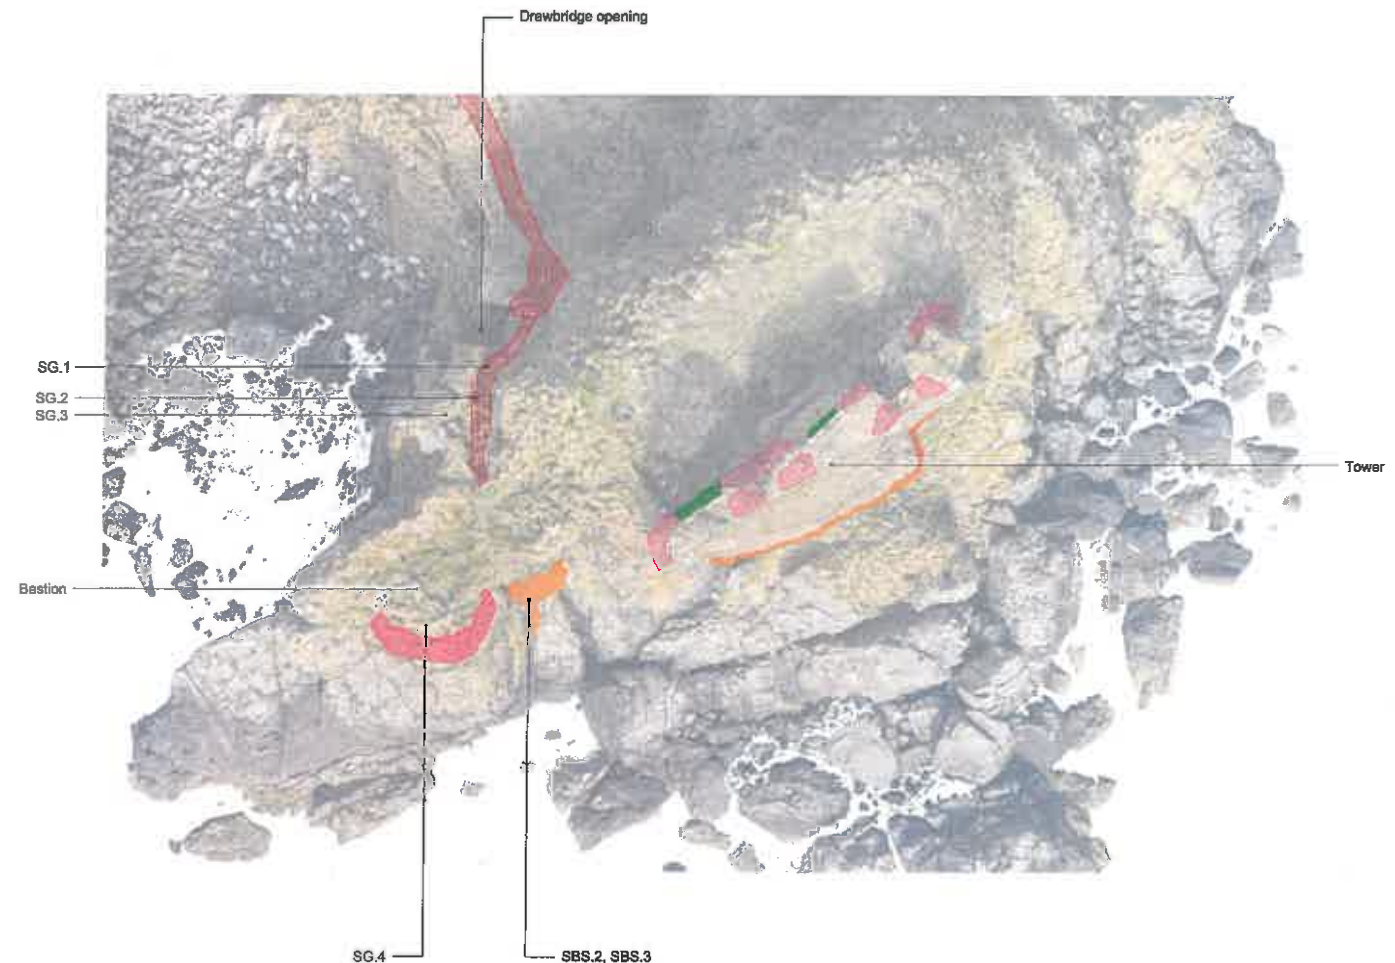
This area is generally in fair condition except for erosion of the footpath and the unprotected edges, so some works in this area are Urgent. There has been no obvious deterioration of the little visible masonry in this area since 2019.

It would be advisable to install signage, or a barrier and alternative interpretation to prevent visitors accessing the Summit and reduce the risk of injury.

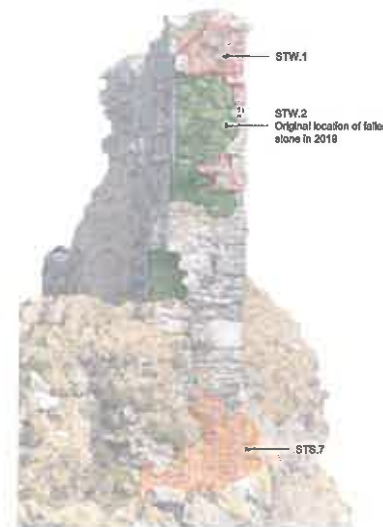
This area is generally in very poor condition as it is very exposed to the prevailing wind from the SW and the broken wall end is nearly vertical and therefore has little protective turf capping. Many works in this area are Urgent. Since 2019, at least one large stone has fallen out on the wallhead and onto the ground.

Rough racking is proposed to stabilise the exposed wall core, especially where the stone has recently fallen out of the wall.

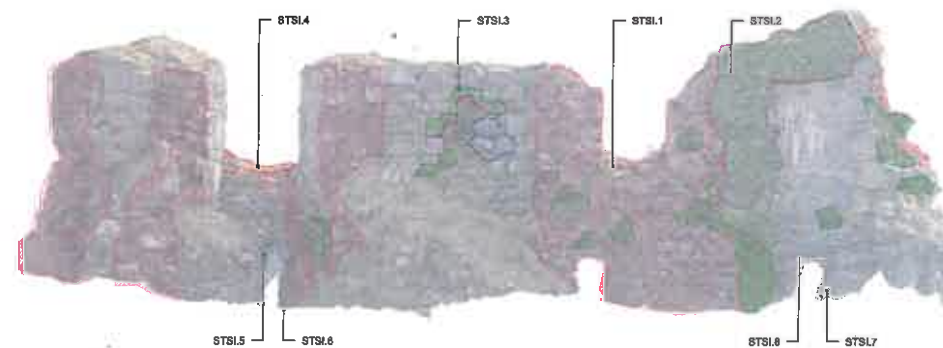
Although the turf cappings are providing some protection, this area is generally in very poor condition as it is very exposed and many works in this area are Urgent. The wall core is exposed at both ends and in many areas including where there are missing walls, floors and quoins. There is a detached inner layer of later c16th masonry that has partially collapsed since 1983 and will continue to do so. Around the lower window openings, there are cracked but stable lintels and sills. Of greater concern are the poorly bonded outer jambs, some of which have been lost, and the long drop to the shoreline below. Since 2019, there has been no obvious loss of masonry except for that noted on the West External Elevation at the SW corner.

Rough racking, underbuilding, pinning, and a non-ferrous bar are proposed to stabilise the exposed wall core, detached inner layer and support higher masonry.

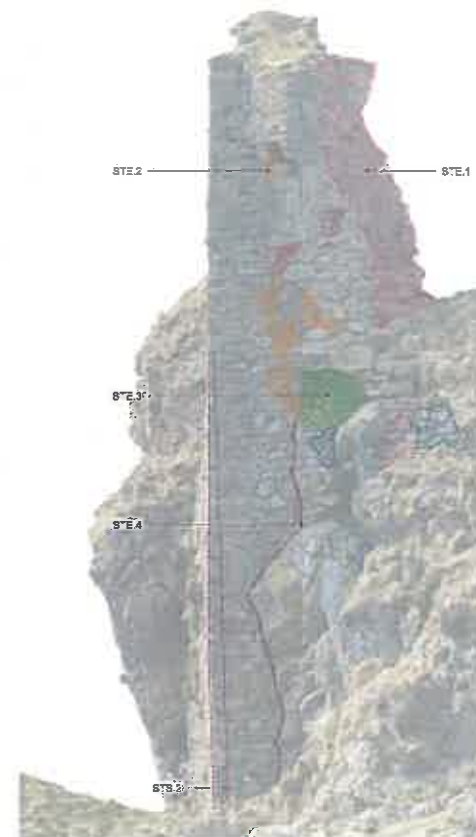
Although turf capping provides some protection, and this walling was subject to limited emergency repairs in 1998, this area is generally in very poor condition as it is very exposed. Many works are Urgent. There are some voids between the walling and bedrock which it sits on and against, and also some areas of unsupported projecting masonry. The wall core is also exposed above ground floor level where the adjacent walls have been lost. There is also a possible bulge to the lower wall that should be investigated further. Since 2019, there has been no obvious loss of masonry.

Rough racking, underbuilding and repointing are proposed to stabilise the exposed core, voids and support masonry above. It may also be necessary to undertake further works to anchor unstable lower-level masonry back to the bedrock.

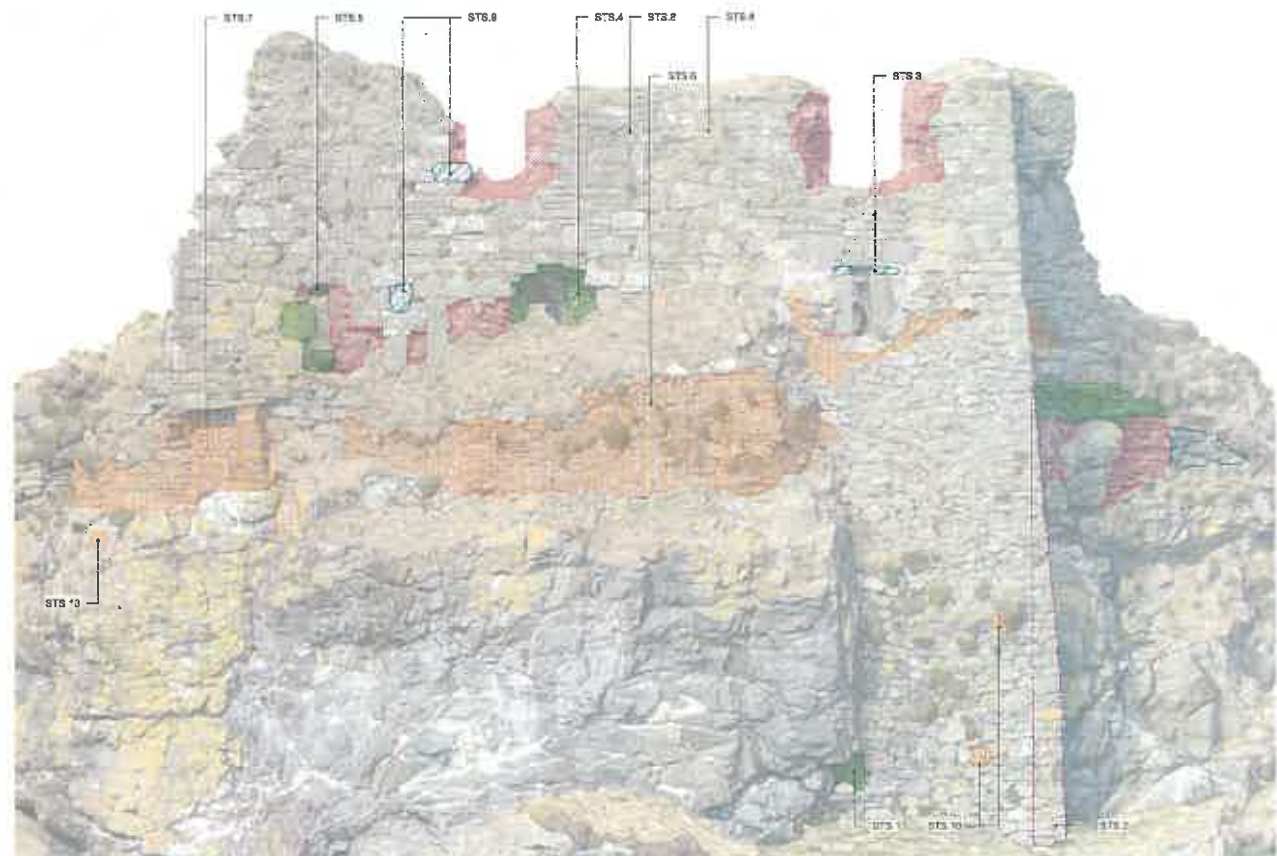
Despite turf capping and previous repairs, this area is generally in poor condition; the core is exposed where quoins are missing, plus window jambs may not be adequately bonded. Many works are Urgent. There is also a possible bulge to the East side of the previously-repaired lower wall that should be investigated further. Since 2019, there has been no obvious loss of masonry except for that noted under Summit - West External Elevation.

Rough racking, underbuilding and packing and pointing are proposed to stabilise the exposed wall core, voids and support masonry above. It may also be necessary to undertake further works to anchor unstable lower-level masonry back to the bedrock.

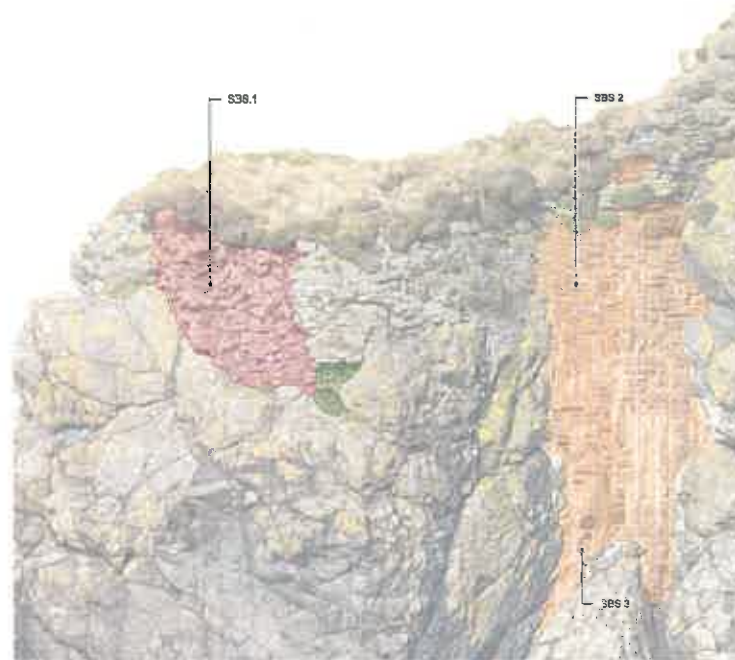
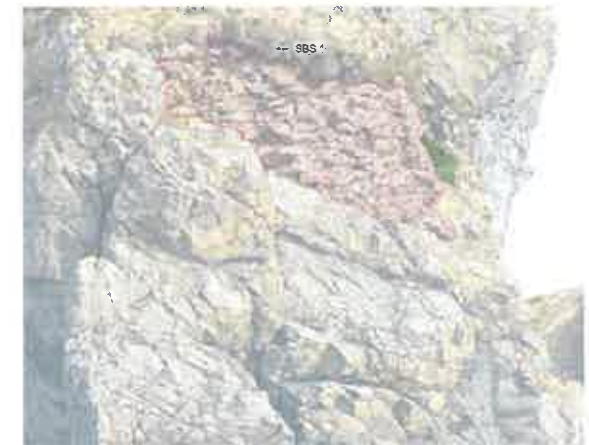
Although the modern stonework is in good condition, albeit marred by heavy lime staining/efflorescence, the Bastion walling is in poor condition with much of the facing having been lost. Some works in this area are Necessary. Since 2019, there has been no obvious loss of masonry although this area was inaccessible and not closely inspected at that time.

Rough racking is proposed to stabilise the exposed wall core.
